Pull Down Motors

Everything you need to know about Pulldown Assemblies

SOFT TOP AND HARDTOP REAR PULLDOWN ACTUATOR ASSEMBLY

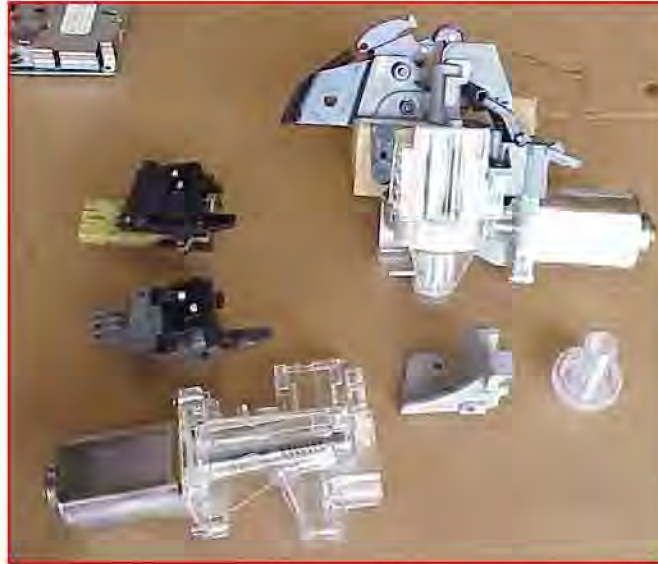
New and rebuilt rear pulldown motors for 1987 through 1993 Cadillac Allantés are available from Allantesource. Please see the "Parts" section for more information. Before ordering, please take a moment to review the following information to help determine if your problem might be an adjustment, or if it's likely that the motor does need to be replaced. If you are looking for information about the motors that latch the front of the convertible tops to the windshield header on 1990.5 through 1993 Allantés, please continue in this section. They are covered after the rear pulldown motors. The most common problem with rear pulldown motors is misadjustment. Symptoms of misadjustment can be any of the following: repeated recycling up and down, failure to stay latched, and failure to latch at all. Before ordering a replacement motor, Allantesource will help you determine if in fact you are likely to need a replacement, or if an adjustment will likely correct your condition. If the motor is dead electrically, check for the ground wire on the latch to make sure it has not broken off. Check for power to the connector. If both are OK, replacement is indicated. The reason pulldown motors sometimes continue to cycle up and down after latching can often be corrected without replacement of the motor. Replacement is required only if the lever on the switch is broken off.

When the rear hook is captured by the latch, the front lip of the hook must depress the switch lever as the latch is lowered by the motor. When the motor trips the main switch at the bottom of its travel, the motor will not recycle upward IF the switch lever is depressed. When it is time to release the hook, by pulling the release lever the hook is freed. This in turn frees the switch lever, which causes the motor to cycle up. If the switch lever is not depressed by the lip on the hook, this will cause the pulldown motor to recycle up as soon as it reaches bottom. If the latch is not released, it will recycle down as soon as it reaches the top, as this is the same condition the pulldown motor sees when it is time to pull down. And it will keep moving up and down until something changes, or the battery wears down. If the latch will not properly capture the hook, sometimes this can be fixed by adjustment. Other times replacement is required. Possible causes are side to side misalignment, binding release cables, or broken or worn latch parts. To check for the cause, leave the soft top cover up. Latch up the rear of the back window. Get in the car. Take a Phillips screwdriver and attempt to push it down into the center of the latch. Make certain it catches and holds properly. Make sure the cables are slack. Then release the latch and lower the rear of the soft top slowly to see how the hook lines up with the center of the latch. Performing all these steps will give you a good chance to see what's wrong. If you have any problems not covered, feel free to e-mail us at allantesource@prodigy.net for further technical assistance.

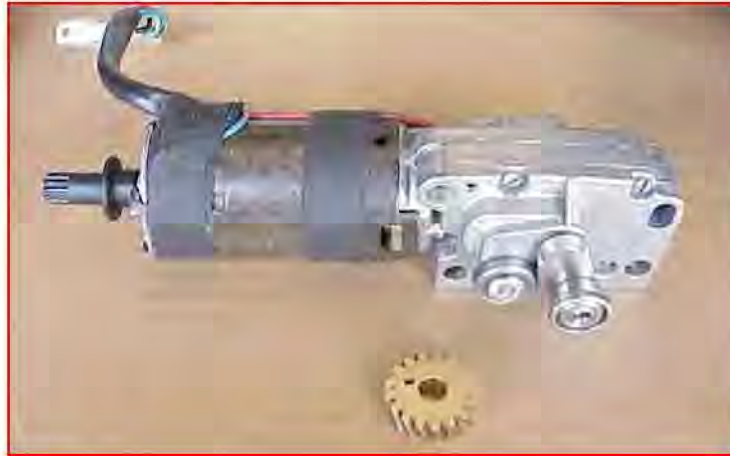
HEADER LATCHING MOTORS 1990.5 THROUGH 1993

There are several possible causes of failure for the front latching motors on the 1990.5 through 1993 Allante's. The small gearhead motors have internal components which break or strip. The motors can fail electrically. And the timer relays which operate the motors can fail. Before ordering replacement motors from Allantesource, please contact us for assistance in diagnosing your problem. The internal gears are not available from any source. We have tracked down and contacted the German company that made these motors. They told us they cannot supply any parts, since the motors are a proprietary product. Now these motors cost around \$900 each from Cadillac, but are now discontinued. We finally had new gears made by a prototype machine shop to enable us to repair these motors.

Early model Allante's had manual clamp hooks that secured the front of the convertible top to the top of the windshield header when the soft top was up. Later models starting with the middle of the 1990 model year were equipped with motorized latches operated by a button located behind the rear seat. The convenience of not having to walk around the car or reach across the car to latch the front of the top sometimes comes with a price, when the motors do not latch properly. The following should help determine what action is needed to fix any malfunctions that might occur.

There are three general types of problems that can be encountered: alignment, mechanical, or electrical. The alignment issue is the quickest to address. There are rollers and locating pins that must be in position in order for the rollers to rotate and lock the front of the top down when the cycle switch behind the driver's seat is pressed. If the motors are both running when they should but not properly engaging the striker plate pockets on the header, the first item to check is the locating pins next to the motors. Are they bent? Do they fall down into the mating holes on the top of the header? Sometimes the bracket holding these pins gets bent. It usually can be straightened. One method you can use to straighten the bracket is to install a 13 mm box end wrench the pin and use it as a lever to pry the pin back into position. Usually when the pin drops down into the locating hole on the header, the roller on the motor will again line up with the pocket on the striker plate.

The next type of problem is mechanical, when the actuator motor cycles but the top is not held down properly. Usually causes for this are internal problems within the gear head. If you hear a ratcheting or grinding noise when you attempt to cycle the motors, this is what you are facing. The assembly must be replaced. Another type of mechanical problem is when one of the internal gears splits, but everything still runs the way it should. The worm gear is pressed onto the roller shaft. When the gear splits, the roller and the gear are no longer locked together. The motor will cycle and shut off, and the top will appear to be latched. But then it can lift up as you are driving. This is a potentially serious problem, as the roof can fly up at highway speed and bend the frame mechanism. To check for this problem, after the front of the top has been latched, go to each front corner and attempt to pull the top upwards.

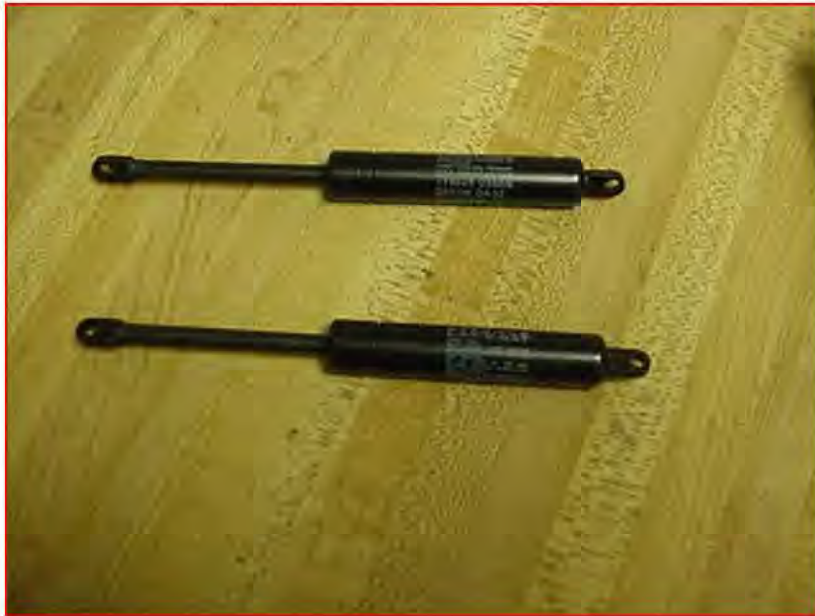
SOFT TOP COVER LIFT STRUTS

The soft top covers on 1990.5 through 1993 Allante's should stay up by themselves when opened. If not, the gas charged struts have lost part or all of their charge. Allantesource has these struts in stock. To replace your struts, it will be necessary to remove the soft top cover from the hinges, then remove the hinges from the car.
